Reconstruction of Sheikhbahaie Dam of Kashan-Iran (Determination of Sediments Filled in Dam Reservoir)

¹Mohammad Mehdi Heydari and ²Ruhollah Mousavi

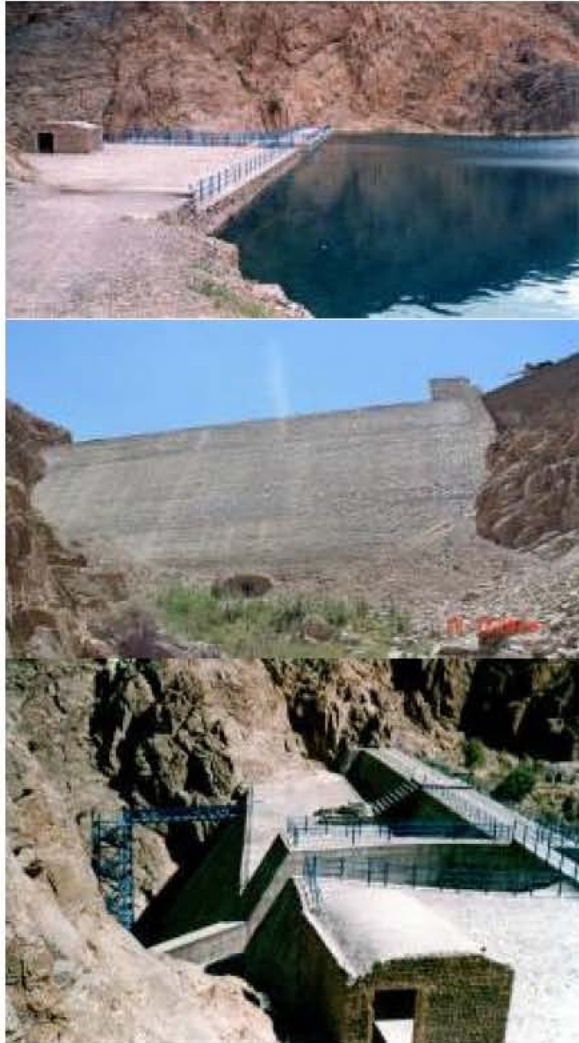
Fig. 1: Ghohrood dam after raised the dam height

mountains, between N33- 35, N33- 43 latitudes and E51-22, E51-29 longitudes, 40 kilometers far from south of Kashan. Average basin height is 2500 m from sea level. The slope extension of drainage basin is northern - southern and about 10 percent. The basin area to the dam site is 79.3 km² with long tree shape channel networks (shape factor of 0.26) and a compaction factor of 1.25 and main river length of 13 km. The height leveling is varied from 3000m in southern extremity ridge to 1900 m in dam site. Flood peak discharge in one thousand year period of the basin is estimated to be 76 m³/s, average annual runoff, 6-8 million m³ and probable maximum flood discharge (PMF), 100 m³/s [4, 5]. Figure 1 demonstrates Ghohrood dam height after it was raised for additional 8 m.

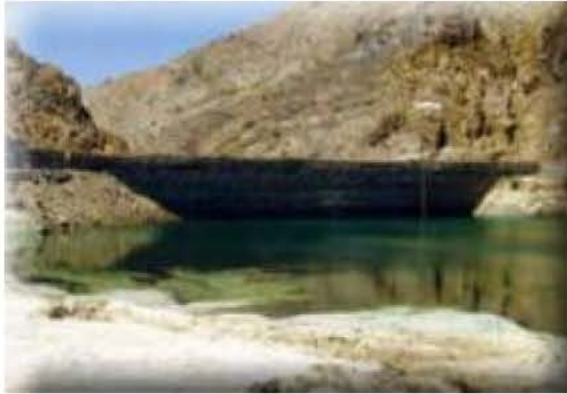
Figure 2 shows Ghohrood dam and its reservoir before sediment discharge and reconstruction.

Fig. 2: Ghohrood dam and its reservoir before reconstruction

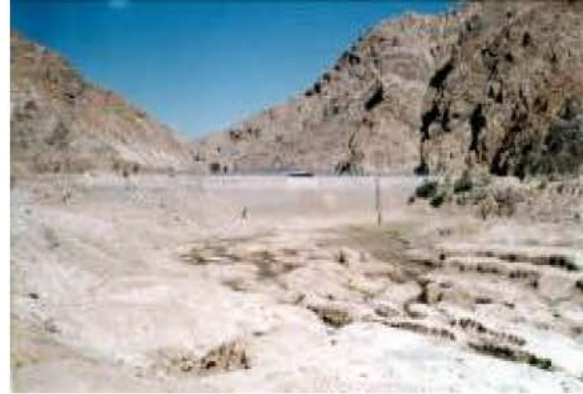
Fig. 3: Reconstructed dam and its reservoir

Figure 3 shows the reconstructed dam and its water reservoir.

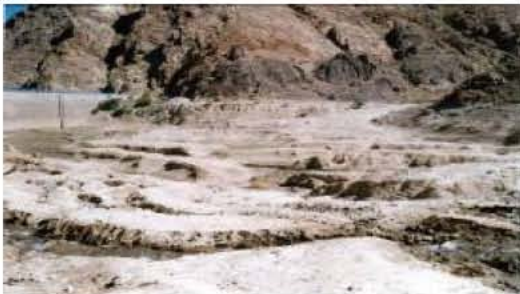
Fig. 4: Erosion of reservoir floor

Figure 4 shows erosion occurred in the reservoir floor of the dam. It is needed to consider the farming lands and gardens created in a wide area of the valley floodway. Sediments behind the dam are silty and loose and the resulted pressure of them is slight. From dam wall to about 200 meters to upstream there were fine grain sediments which their diameters are less than 5 mm and are rarely less than 10 mm. Flood flow with a maximum rate of 1.15 m/s, may carried out these articles and resided them behind the dam. This rate was obtained. For a flood with a flow discharge rate of about $11 \text{ m}^3/\text{s}$ proportional to the cross section and slope of the river bed in upstream [9].

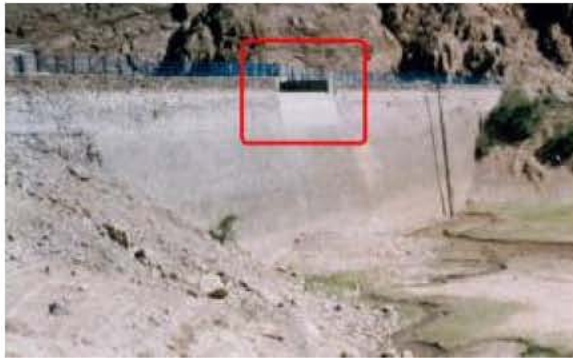
Figure 6 demonstrate the position of upstream of the dam spillway.

Fig. 6: Upstream of dam spillway
