Valuation of Traditional Turkish Wooden Building Culture in Terms of Ecological and Socio-cultural Sustainability, Case Study Cumalikizik/ Bursa

Rengin Beceren Ozturk and Arzu Ispalar Cahantimur

Department of Architecture Uludag University, Faculty of Engineering and Architecture Bursa/Turkey

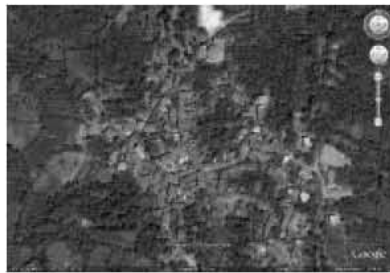
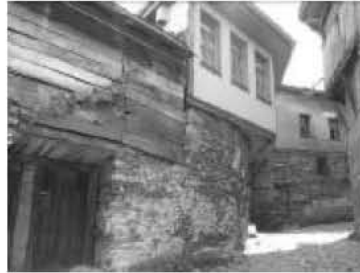
Fig. 1: Examples of Traditional Wooden Buildings in Turkey

Hajji Ibrahimoglu House, Rize
www.ahsap.com

Traditional house, Safranbolu
[www. Tenkafesi.com](http://www.Tenkafesi.com)

Wood material is frequently and differently used all over Turkey, especially in coastal areas, because of ease of supply, opportunity of timber supplement in different forms and lengths, alternatives for carriage, flexible usage, ease of repairing and montage. Turkey has unique weather conditions caused by its geographical structure as; being surrounded with seas, the relation of the mountains with the sea and the variety in ground shapes. Moreover Turkey is highly substantial on its forestalling areas especially in coastal regions. The wooden houses which are the best examples of civil architectural heritage in Turkey are located especially near shore and forest sides, densely in the Marmara, the Black sea and the Aegean regions [4].(Fig.1.)
