## Managing Local Scour Downstream of Cross-River Structures Case Study: Balaroud Inverted Siphon

<sup>1</sup>B. Lashkar-Ara, <sup>2</sup>S.MH. Ghotbi and <sup>2</sup>A. Armaghani

<sup>1</sup>Jundi-Shapur University of Technology, Dezful, Dezful, Iran

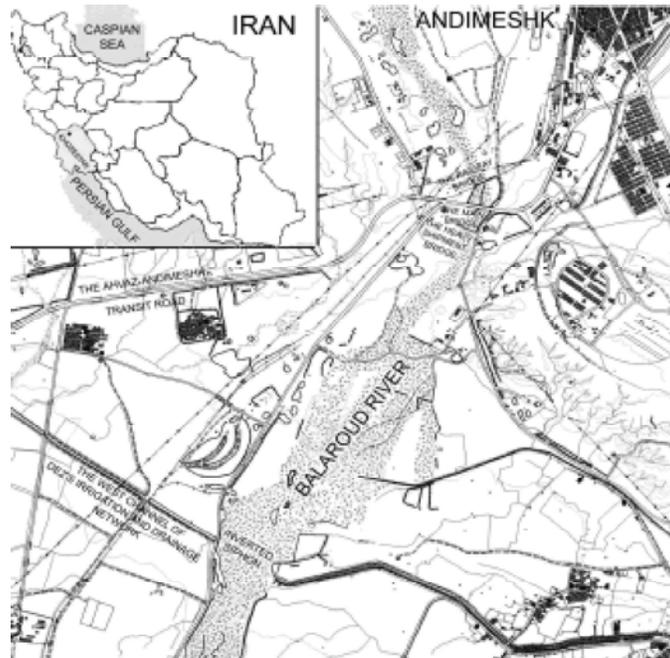
Fig. 1: Location of the steady area

**Problem Definition:** The study area is a part of Balaroud river, located in the south west of Iran. The west channel of Dez irrigation and drainage network with capacity of 157 cubic meters per second, irrigate 50000 hectares from Andimeshk and Shoush area, cross the Balaroud riverbed by means of an inverted siphon structure (Fig. 1).

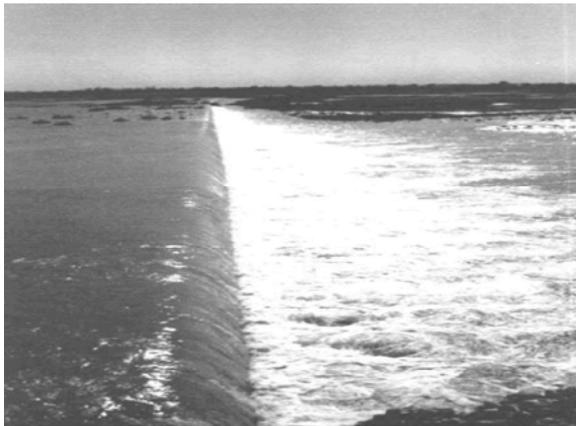
Fig. 2: Flow over the top of inverted siphon

Fig. 3: Scour at right side of Balaroud inverted siphon as a grade control structure in the river bed (Fig.2). Because of this, a deep scour hole was observed three years ago on the right hand side of the river bed

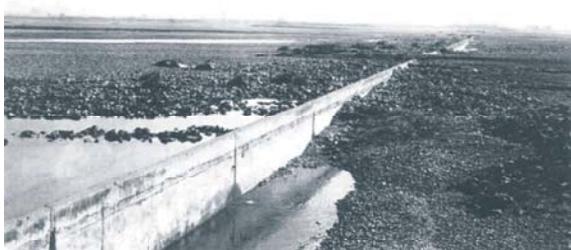
downstream of the structure after a flood (Fig.3). Because of the importance function of the siphon and the possibility of its failure, a study was conducted to investigate the cause and to determine any reliable measures for controlling the scour hole. This paper will briefly present the results of this investigation.

When a river and or slope profile has sudden drop in the longitudinal or flow direction, the excessive kinetic energy at falling jet strongly impacts the riverbed and result in a scour hole. Such scour holes can often be observed in incised rivers and gullies [6]. In field visit, a strong scour and expose buried foundation of siphon structure has been observed. Because the morphology of riverbed in this section is arterial, parts of scour hole continue and connected to thalweg in downstream. Figure 3 has been shown result from jet scour and head-cut halted by Balaroud inverted siphon structure.

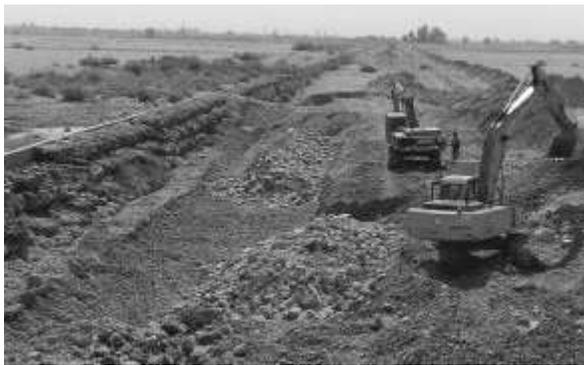
Fig. 9: The bed downstream was covered with natural stone

From the hydraulic and economical point of view, the alternative C was selected for managing the process of scouring in the Balaroud river. The scenario C was carried out and to protected the structures, the bed downstream was covered with natural stone like an stilling basin. (Fig. 9).
