Reconstruction of Sheikhbahaie Dam of Kashan-Iran (Determination of Sediments Filled in Dam Reservoir)

¹Mohammad Mehdi Heydari and ²Ruhollah Mousavi

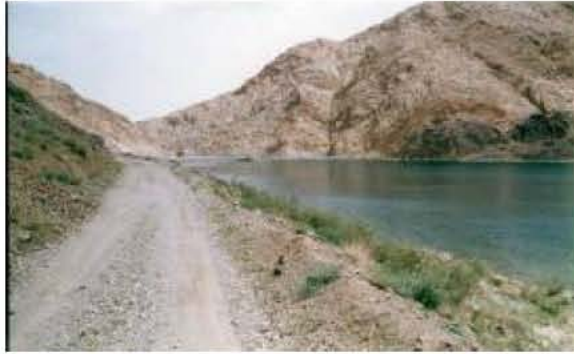
Way of Access to the Dam: The dam is located in a relatively tight valley and there is no way to access the dam from downstream. In order to access Ghohrood dam from upstream, there is a dirt road toward dam structure (with a distance of 2500 m). A mountain shearing has been operated to make this road in 500 to 600 meters far from upstream of the dam [2]. The dirt road having access to the dam is shown in Figure 5.

Fig. 5: Access way to the dam
